# NBS SPECIAL PUBLICATION 592

## An Investigation of the Miyagi-ken-oki, Japan, Earthquake of June 12, 1978

On June 12, 1978, a destructive earthquake with Richter magnitude of 7.4 occurred off the east coast of Miyagi Prefecture, Japan. Preliminary estimates by the National Land Agency of Japan indicated that the earthquake caused an equivalent of \$800 million in total damage. There is a cooperative agreement between the governments of the United States and Japan termed the U.S.-Japan Program in Natural Resources (UJNR). Following the earthquake, it was arranged through UJNR that teams of U.S. structural engineers and geologists would visit Miyagi Prefecture and inspect the damage caused by the earthquake. This report assembles the information and collective experiences of the investigation team so as to describe the earthquake and document its effects. Field investigations conducted by geologists and structural engineers are described in detail and some of the implications for seismic resistant design and construction of structures in the United States are also discussed.

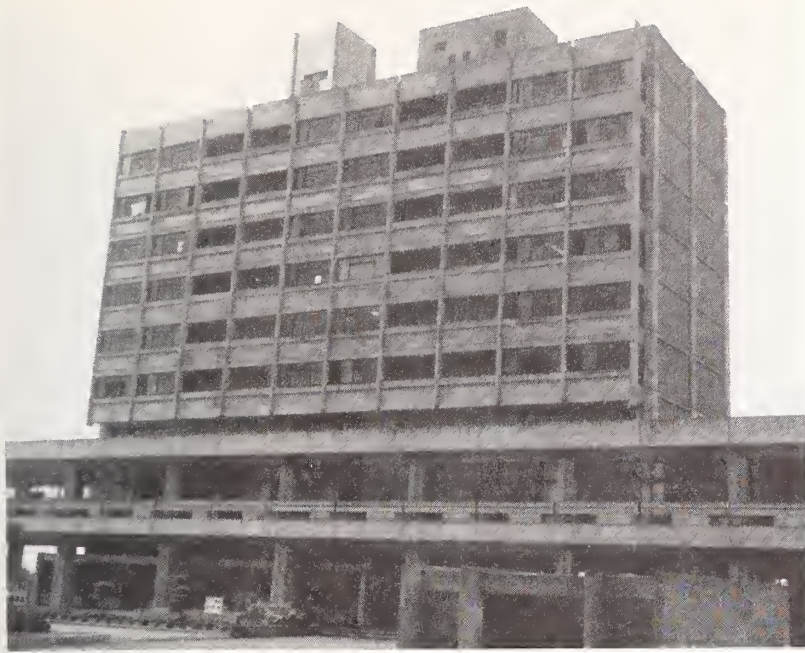
Tohoku University is situated in the northwest part of Sendai, in the district of Aramaki, an area of hills and steep terrain. The Engineering Building is a reinforced concrete framed structure and is built on a reasonably flat area, but a steep cliff falls off close to the rear of the building. Figure 4.4 is a photograph of the central 9-story tower and also shows the two lower levels which cover a larger plan area. A floor plan and two elevations are shown in Figure 4.5. Two SMAC-M instruments are installed in the building, at ground level (there is no basement), and at the 9th floor level. They are on the same vertical line, against an exterior wall of the central tower, as shown in Figure 4.5. These instruments record on FM analog tape, and functioned correctly during the earthquake.

Engineering Building,  
Tohoku University,  
Aramaki, Sendai.

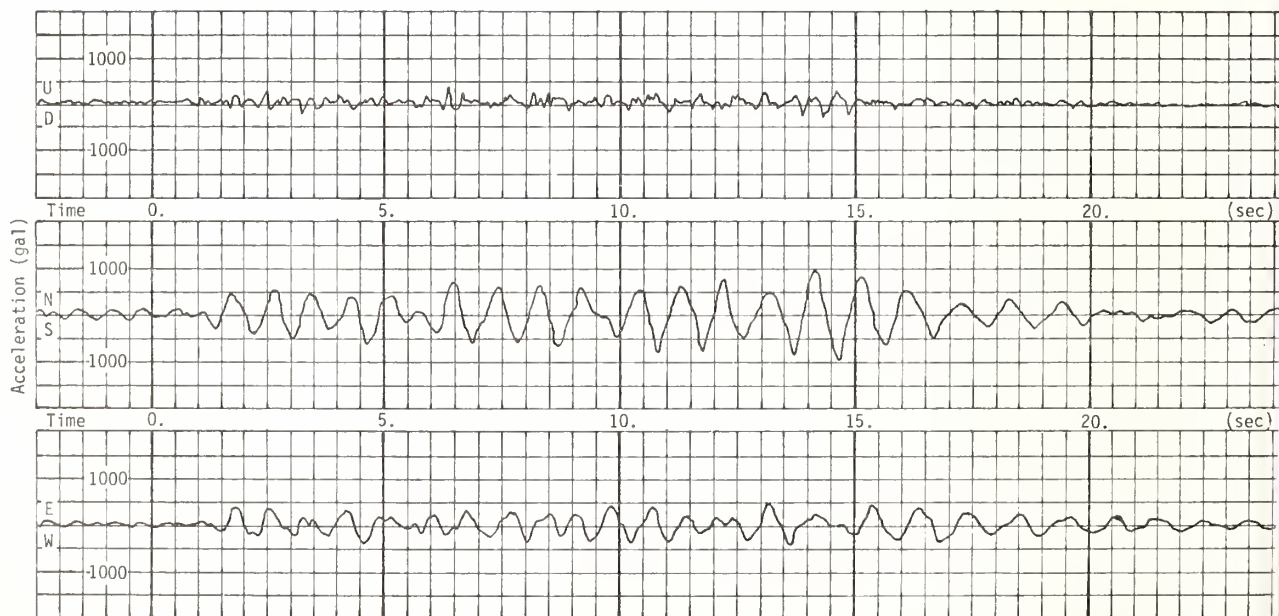
Figure 4.6 shows a 25-sec portion of the record from the ground level instrument, after A/D conversion. The peak horizontal accelerations are 240 and 190 cm/sec/sec, and the peak vertical acceleration is 150 cm/sec/sec, as indicated in Table 4.1. Figure 4.7 shows a similar plot of the 9th floor record peak values of 980, 480, and 300 cm/sec/sec (Table 4.4). A preliminary analysis of the high-amplitude oscillations in the horizontal directions at this level indicate that the corresponding displacements are approximately 10 in (25.4 cm). This is consistent with the damage in the interior of the building, (discussed in Chapter 5), and indicates the building was approaching the structural damage state.

Figure 4.7 Three components at 9th floor level, Engineering Building.

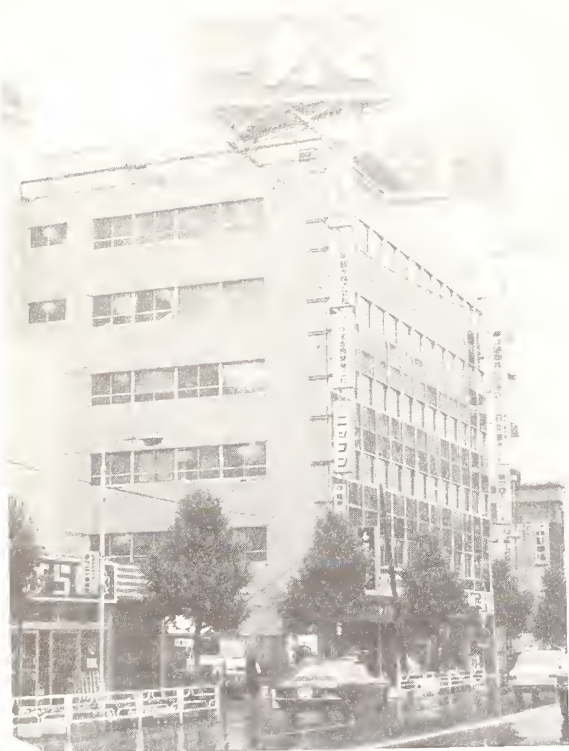
Figure 5.4 Minami Machidori Building, Sendai. The cracking to the brick veneer is typical for many similar buildings in the city.

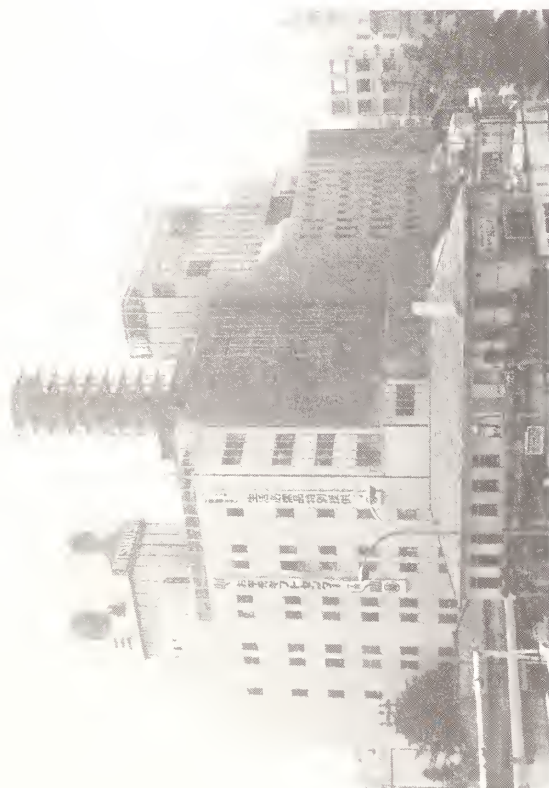
Figure 5.8 Chimney damage to the Mitsukoshi Department store. Numerous such chimneys suffered such damage.

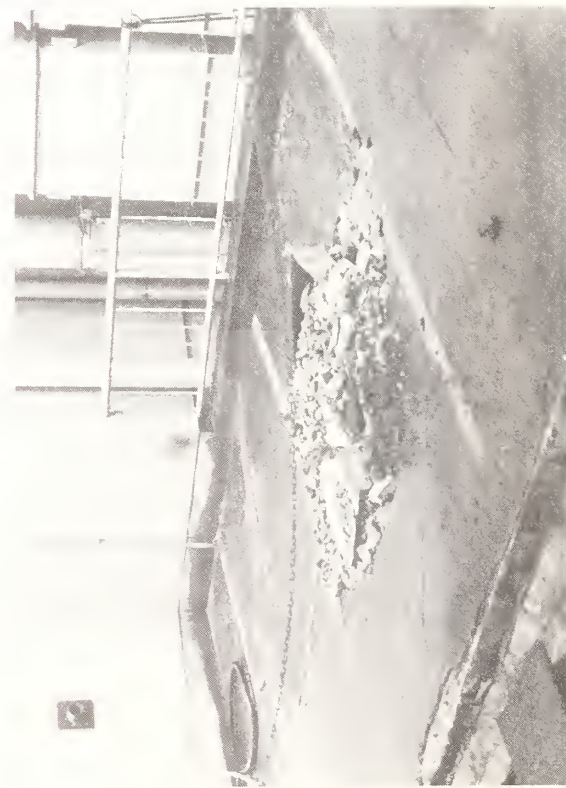
Figure 5.10 Impact area of chimney failure (see Figure 5.9)

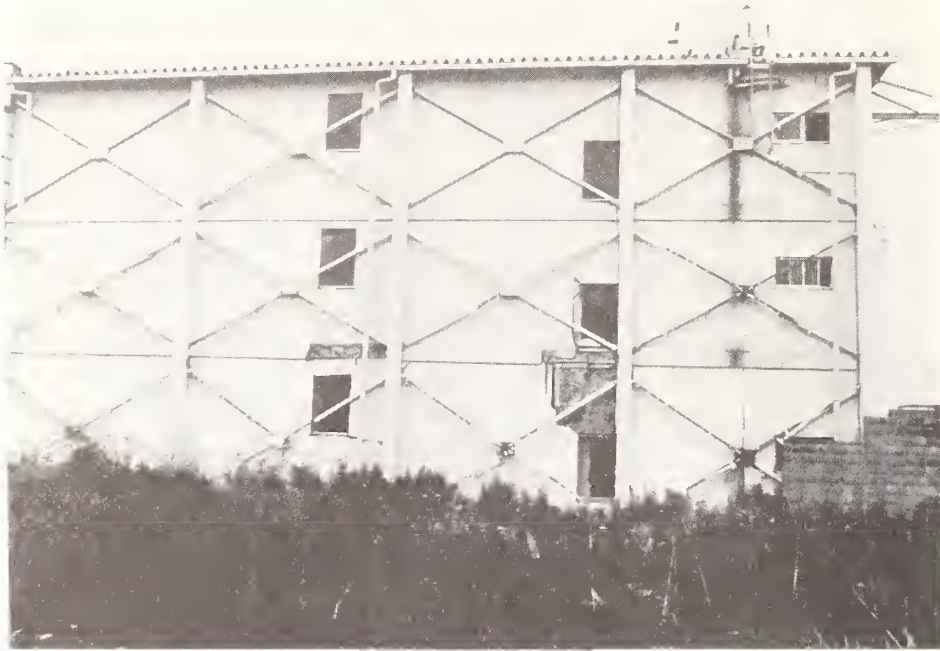
Earthquake resistance in steel buildings is provided either through the use of moment-resisting frames or through diagonal bracing. When braces are used as earthquake resisting elements, it is normal practice to design them so as to carry all of the horizontal force. An example of such a structure is a steel framed furniture warehouse on the outskirts of Sendai shown in Figure 5.11. There were many examples where the bracing members buckled under stress reversal or the connections failed. A number of the transverse diagonal braces used in this warehouse sheared at their bolted cross connections (Figure 5.12).

Figure 5.11 A damaged steel-framed furniture warehouse on the outskirts of Sendai.

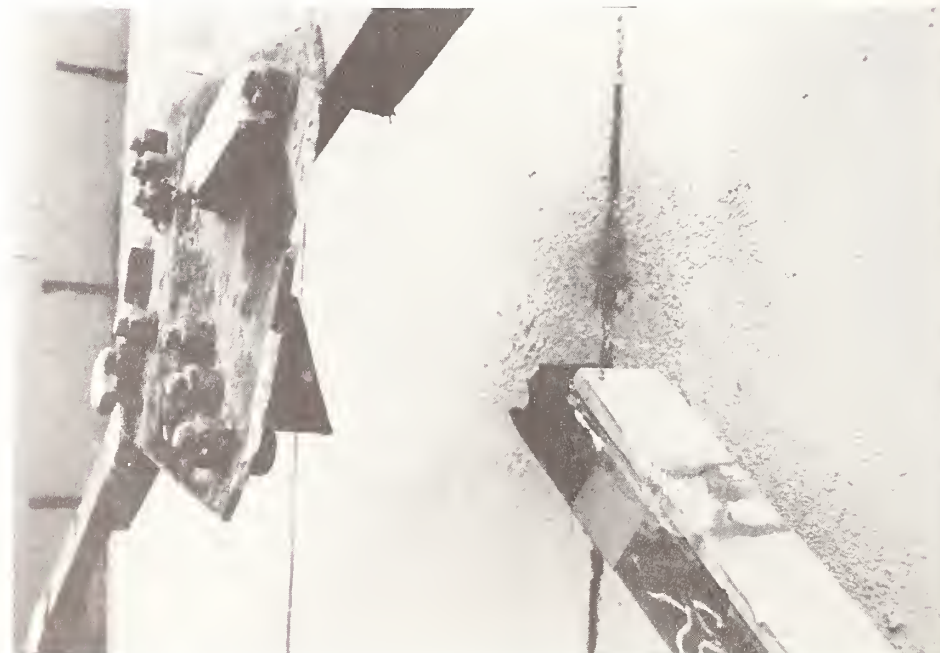
Figure 5.12 Detail of failure in transverse diagonal braces.

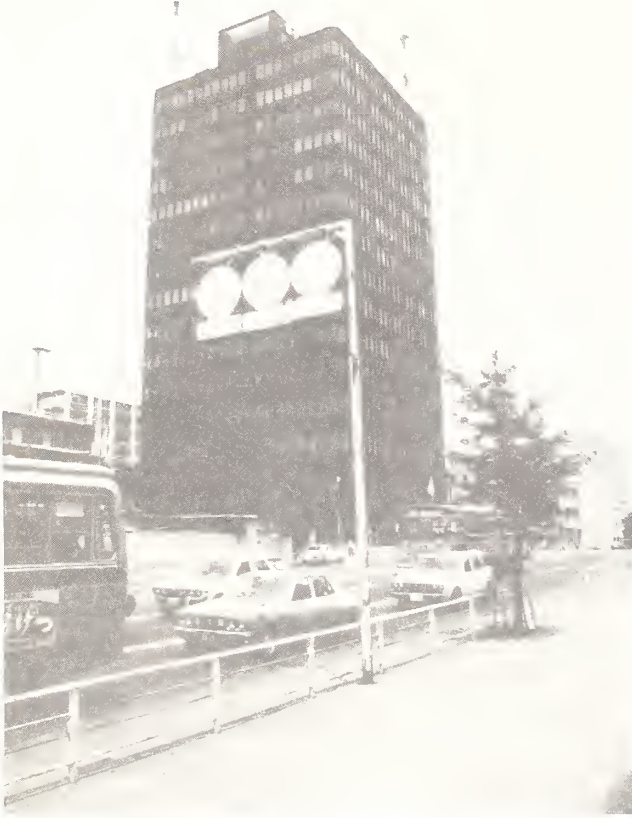
Many modern high-rise buildings in Sendai have steel frames, and these generally performed very well during the earthquake. One example is the Sendai Second Government Building in the downtown area (No. 2 in Figure 5.3), a 17-story structure built in 1973 (Figures 5.13 and 5.14.) The building is situated on a raft foundation, where the underlying soil conditions are good. The frame was designed by dynamic analysis for a maximum base acceleration of 0.2 g. The building is instrumented with strong motion accelerometers at the 15th floor and second basement levels, and a downhole at 40 m below grade. The building suffered virtually no damage, although there was some minor diagonal cracking in the concrete stairwells leading to the basement.

Figure 5.13 Sendai Second Government Building. This modern steel frame structure suffered no damage.

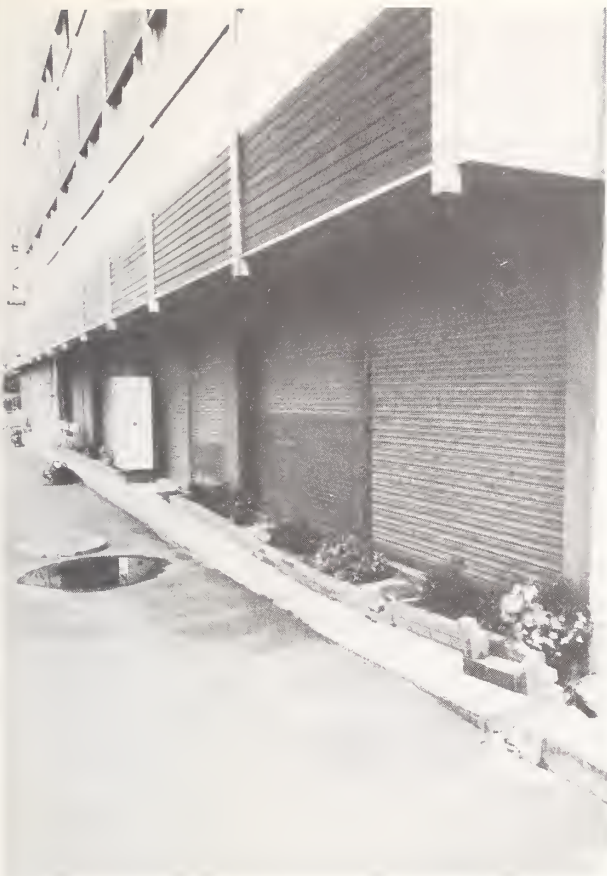
There was extensive evidence of ground settlement in the Oroshicho area, including settlement of asphaltic concrete sidewalks and slumping around building foundation walls, as in Figures 5.20, and 5.21.

Figure 5.20 Oroshicho area, Sendai.  
Ground settlement.

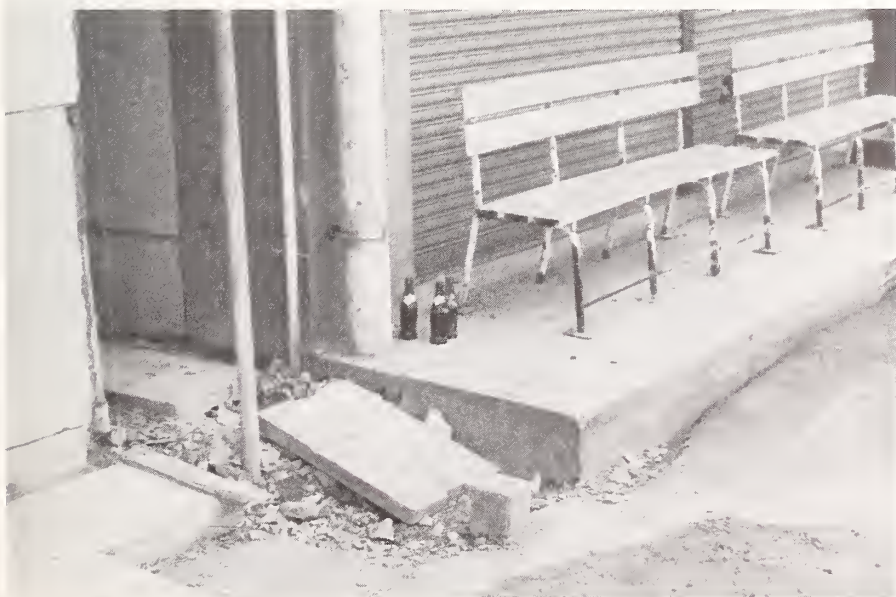
Figure 5.21 Oroshicho area. Sidewalk damage  
caused by ground settlement.

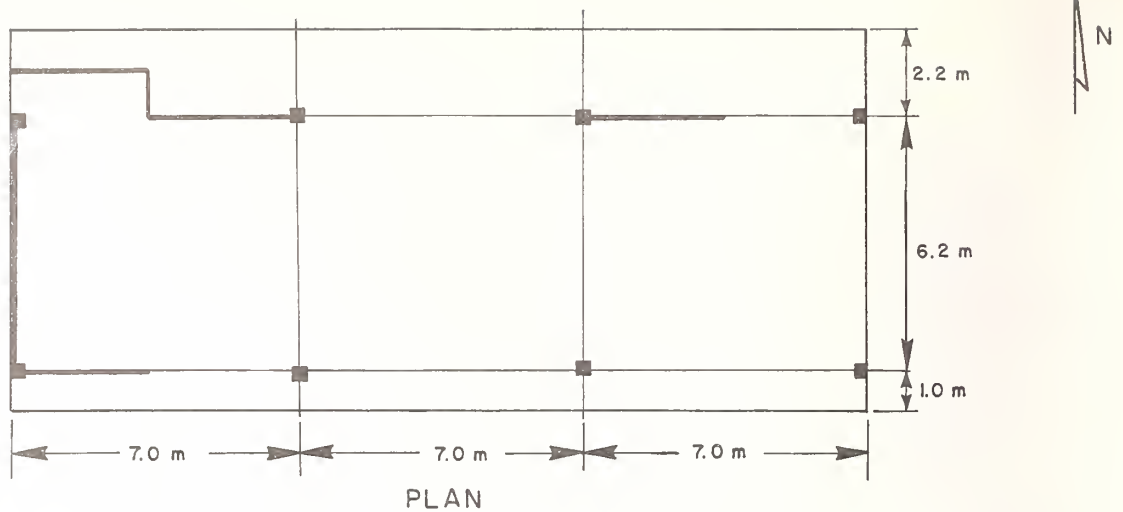
Maruyoshi Building (No. 6, Figure 5.3). This was a three-story reinforced concrete frame building, one span by three, with the long axis of the building running in the E-W direction. There was a 2 m overhang on the north side of the structure (Figure 5.22). The wall shown at the west end was continuous from the second-story on up. The building had a flexible first-story. The building suffered extensive damage to the first-story (Figure 5.23) and, as shown in Figure 5.24 was tilting toward the north. The first story columns on the south side of the building failed in shear due to the strong N-S motion. A detail of the beam-column joint where the second-story floor beam frames into the first-story column is shown in Figure 5.25. Column ties appeared to be spaced at about 300 mm. The shear wall on the west end of the structure appeared to be undamaged. Unfortunately, this caused the structure to behave as an inverted pendulum and caused the first-story columns to accept even more shear. Note the use of the undeformed bars in the beam-column joint (Figure 5.25).

Figure 5.22 Plan view of Maruyoshi Building, Oroshicho area. Note overhang to the north.

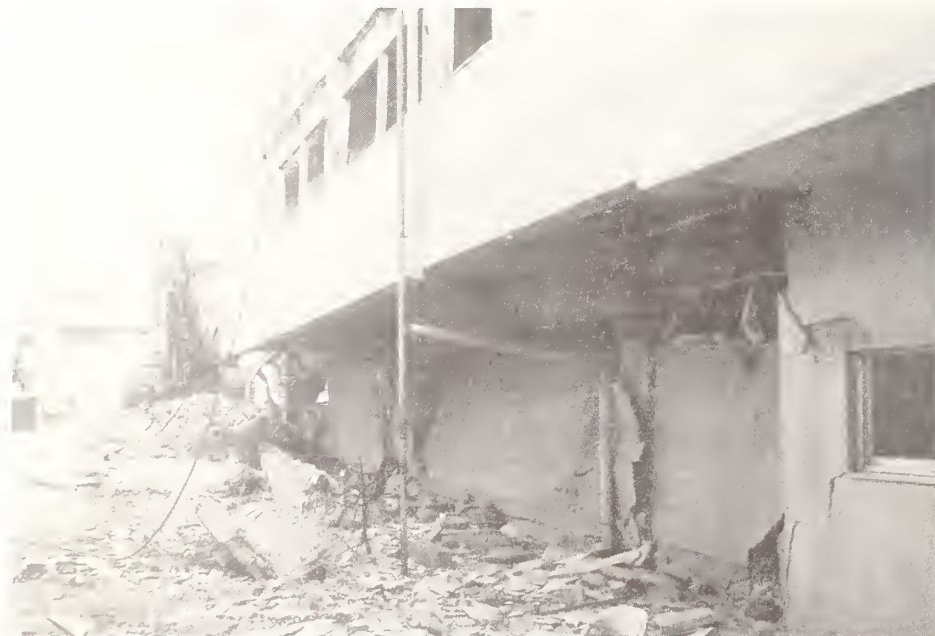
Figure 5.23 Maruyoshi Building, view from the northwest. This three story reinforced concrete frame, one span by three, suffered almost total collapse of the first floor.

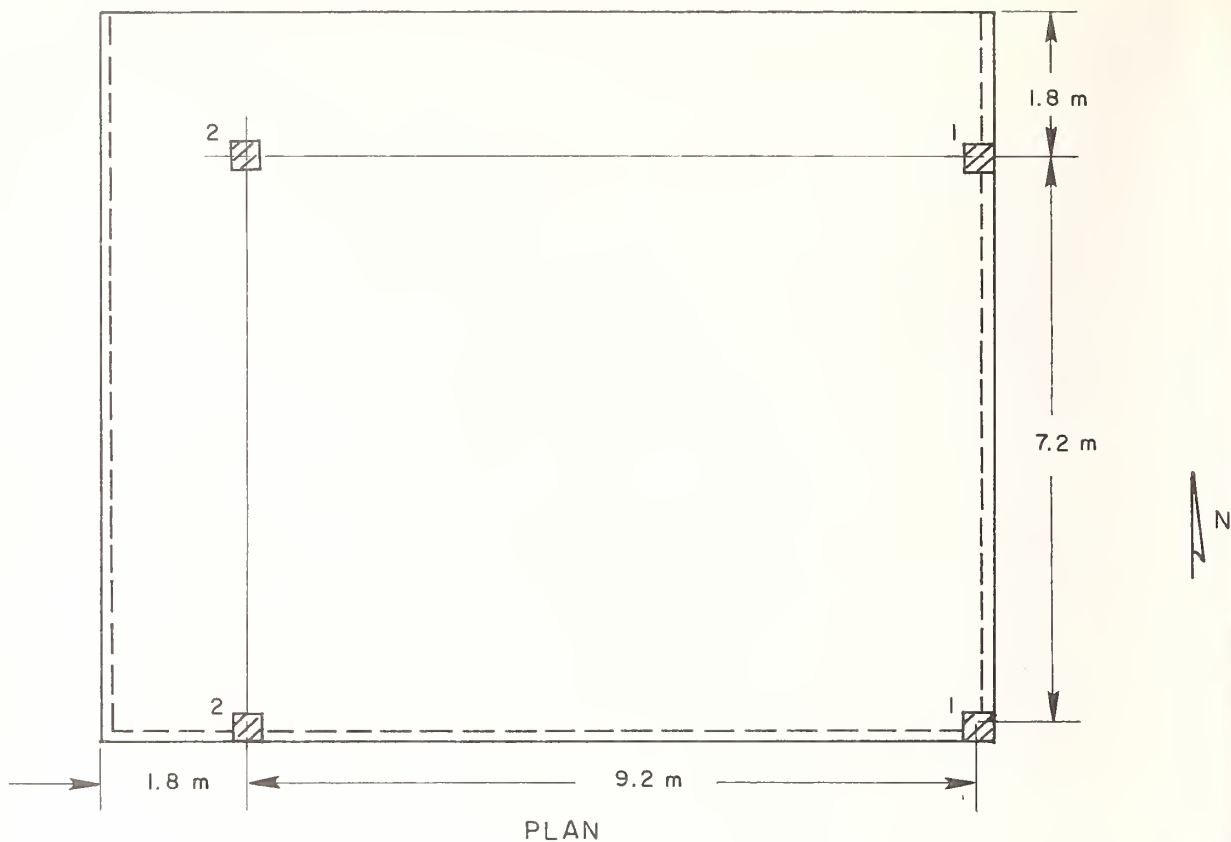
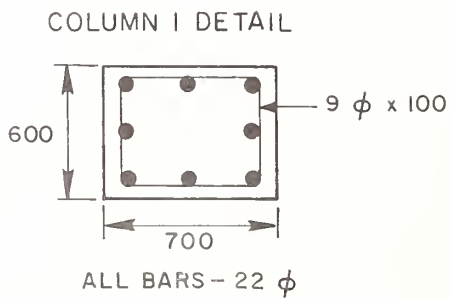
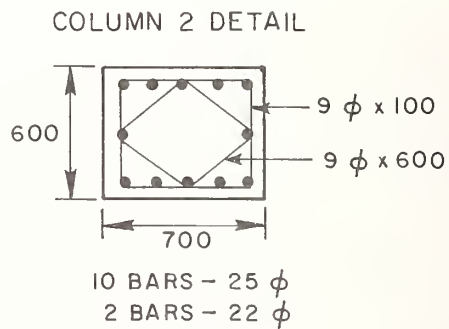
Figure 5.26 Plan and column details of Obisan Building, Oroshicho area.

Obisan Building (No. 7, Figure 5.3). This was a three-story reinforced concrete frame building with one span in each direction (Figure 5.26). The portion of the building which overhung the column line by about 2 m contained a heavy stairwell. There were no openings in the overhanging part of the building, which added to the eccentric mass. Coupled with the strong N-S motion, this caused a failure in torsion as the columns at the west end of the building were unable to withstand the forces resulting from the large eccentric mass. Figures 5.27 and 5.28 show the Obisan Building after the earthquake viewed from the north and south, respectively. It may be observed that the upper stories rotated almost as a rigid body when the first floor columns failed. The first-story of the building had been used as a display area, and was completely open. A detail of the SE column is shown in Figure 5.29 and in the plan. As shown in Figure 5.30, the first floor support beams were practically resting on the ground at the west end of the building. The walls above the first-story suffered extensive cracking during the earthquake, but remained intact (Figure 5.31). The reinforcing bars that can be seen are undeformed.

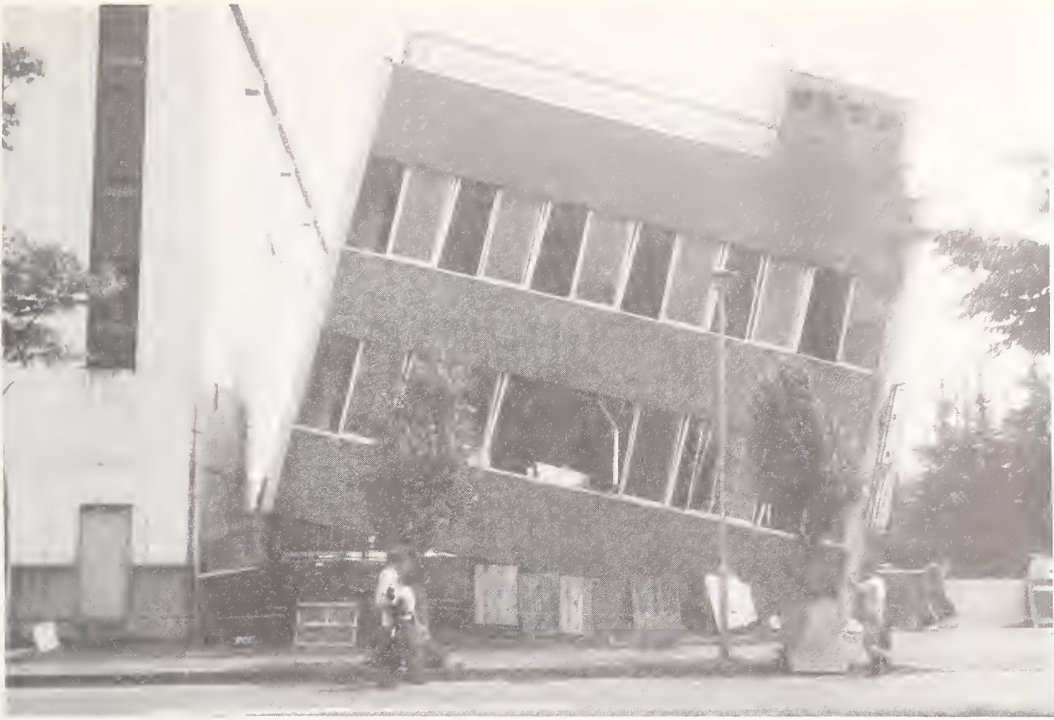
Figure 5.27 Obisan Building, viewed from the North. This three story reinforced concrete frame building had a heavy eccentric stairwell cantilevered over the column line at the right end of the building.

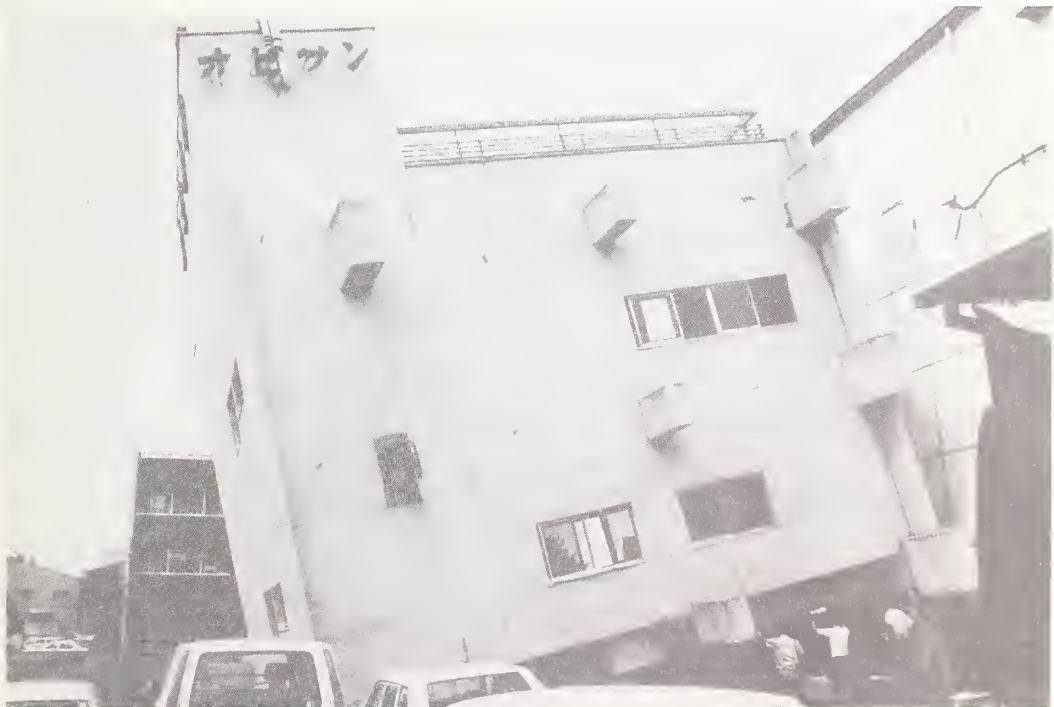
Figure 5.28 Obisan Building, viewed from the south. The upper stories rotated as a rigid body when the first floor column support was lost.

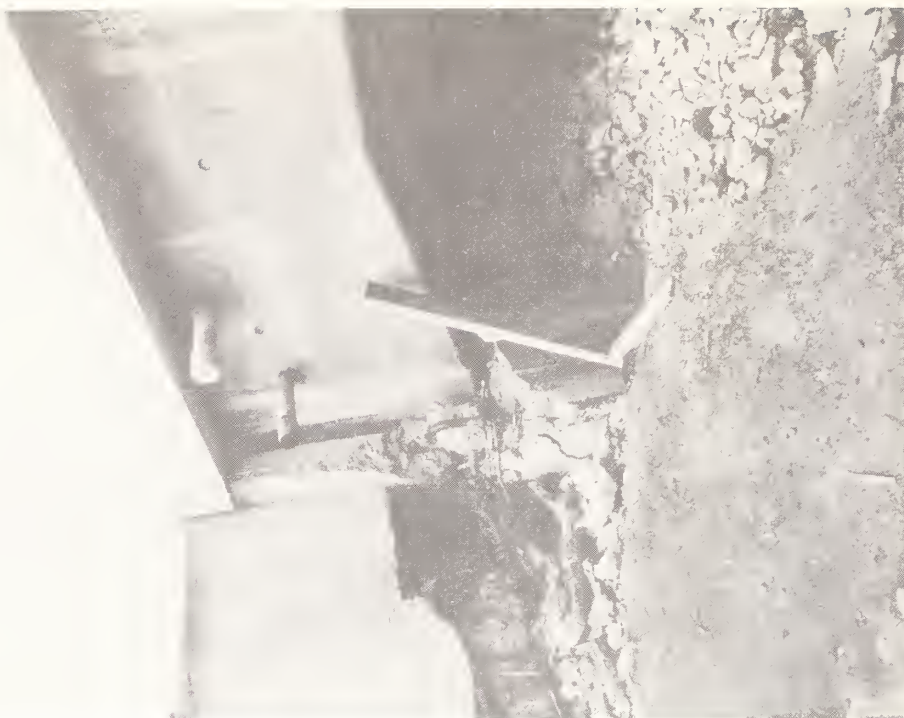
Figure 5.30 Obisan Building, detail of southwest column adjacent to overhang.

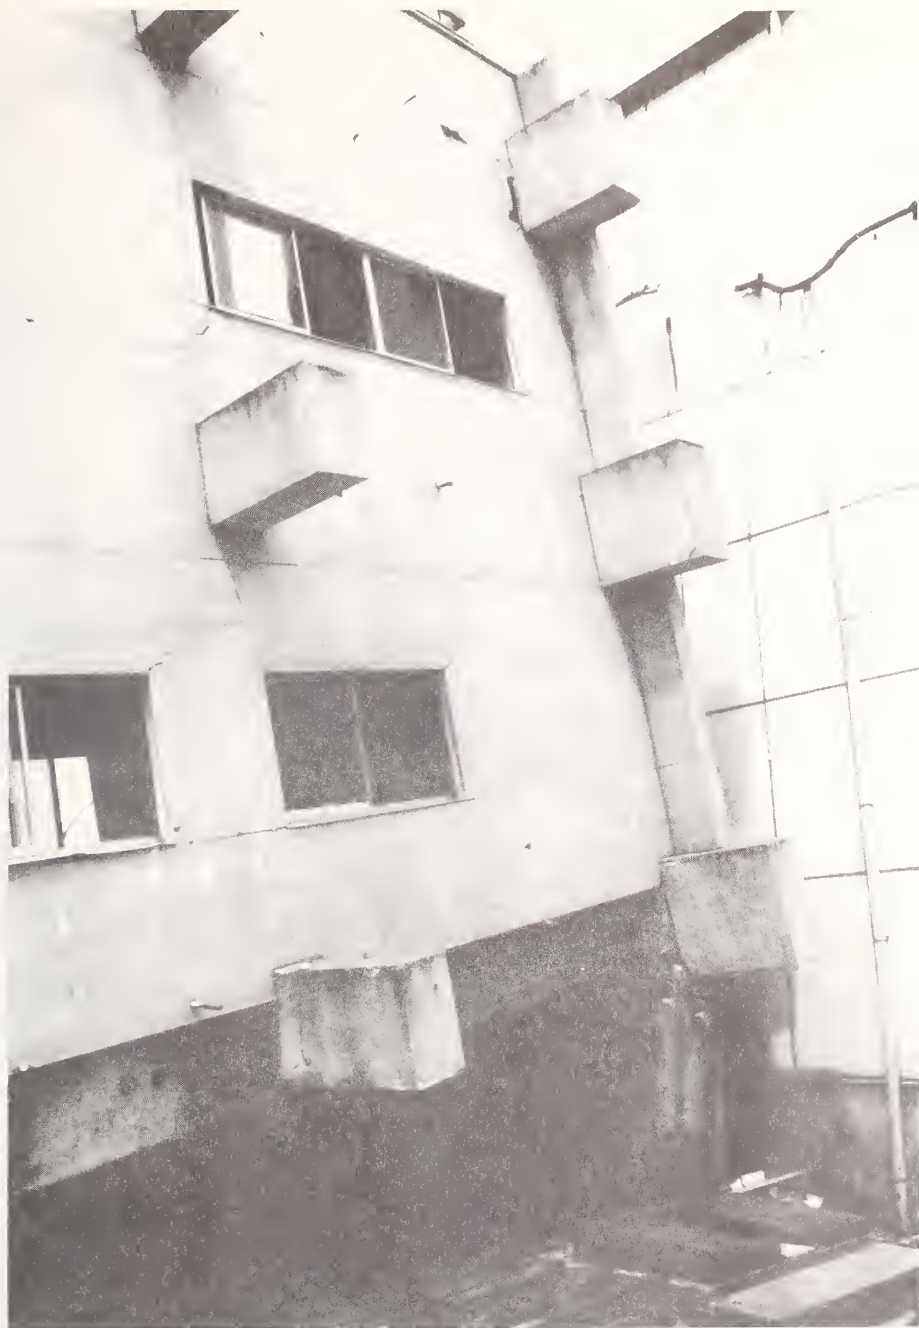
Figure 5.31 Obisan Building, south face. Walls above first story remained essentially intact.

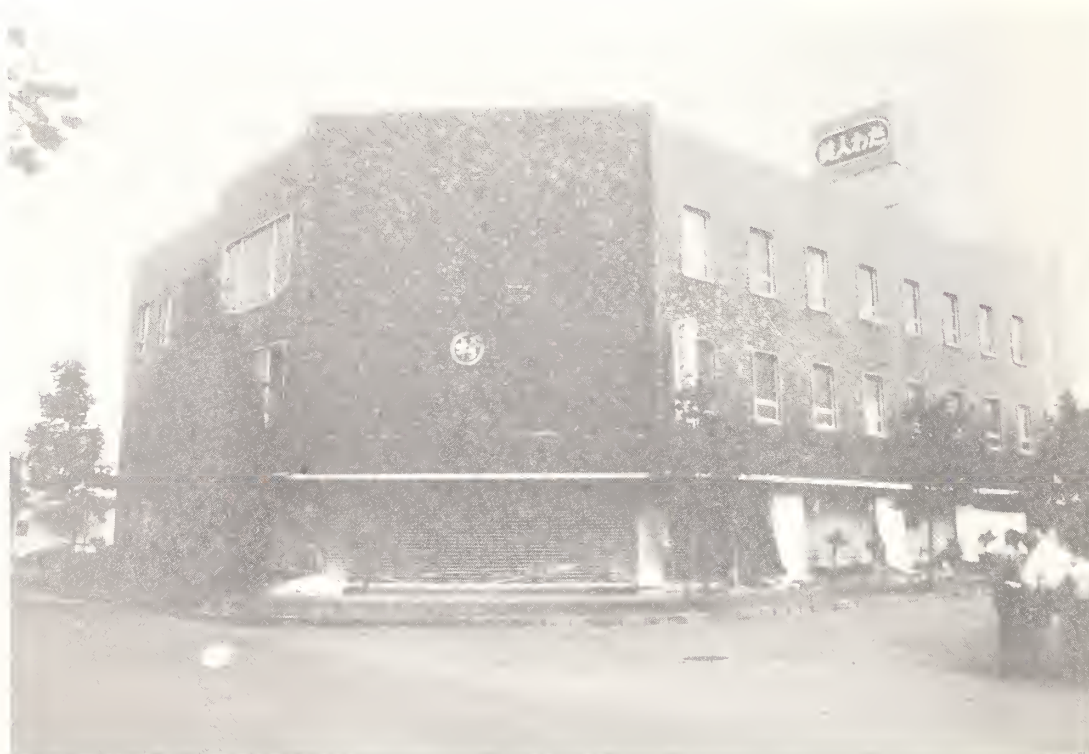
Kinoshita Building (No. 8, Figure 5.3). This three-story reinforced concrete frame building, two spans by six, had its main axis in the N-S direction. As shown in Figure 5.32, there was extensive diagonal cracking on the east face. The first floor on the west side of the building, Figure 5.33, was used as a showroom. Unlike the backside of the building, where the columns were stiffened by spandrels, the columns on the west side were relatively flexible, and there appeared to be very little damage on that side of the building. The brick facing on the west side remained intact. The interior columns on the east side of the building showed large shear cracks and buckling of exposed undeformed bars. A reinforced masonry partition wall also failed here. It is apparent that most of the seismic force was attracted to the relatively stiff east side of the building. In addition, there appeared to be significant settlement of about 100 - 150 mm in the interior of the building on the east side. This, along with the relative stiffness of the east face, would explain the diagonal cracking pattern observed on the east face as well as cracking patterns observed in columns and panels. Failures of this sort were also observed following the Niigata earthquake (Okamoto, 1973).

Figure 5.33 Kinoshita Building. The brick facing on the west side of the structure showed little sign of damage.

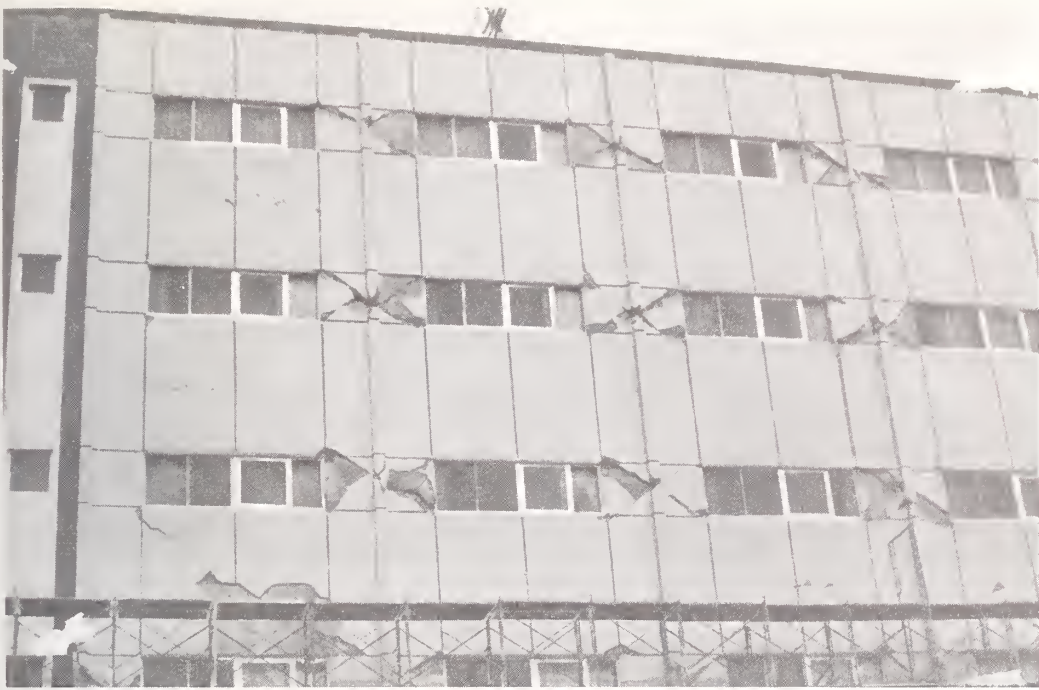
extensive diagonal cracking in the panels between window openings on both east (Figure 5.34) and west faces (Figure 5.35); this damage is especially severe on the west face, as shown in the detail in Figure 5.36. The decorative ceramic brick facing on the north side of the building did not appear to be damaged.

Figure 5.36 Maruhon Building, west face. Detail of the damage to panels between windows.

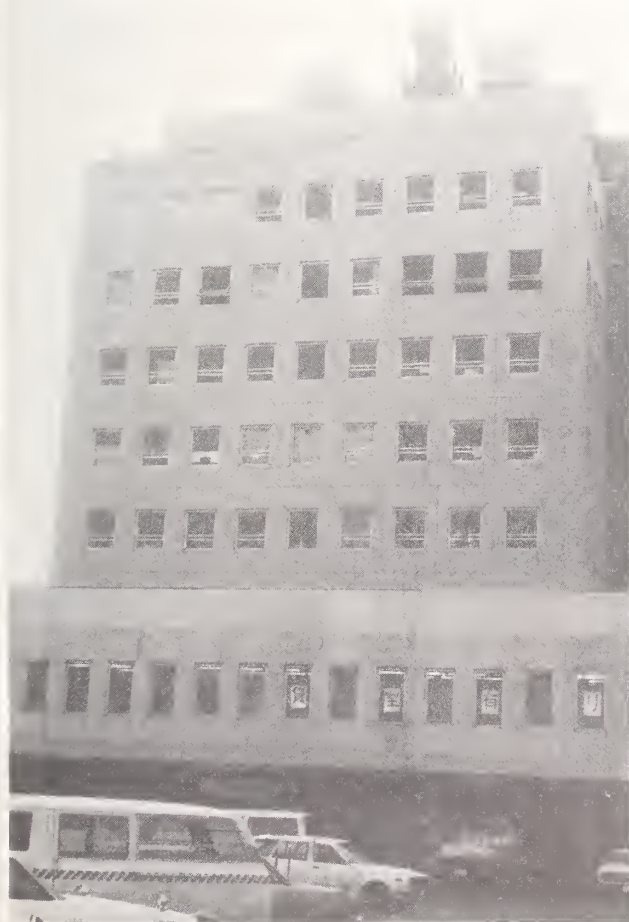
Despite the level of damage in the Oroshicho area, many buildings performed quite well. As an example, Figure 5.37 illustrates a 9-story building which was only slightly damaged. No details about its construction are known.

Figure 5.37 A slightly damaged 9 story building in the Oroshicho area of Sendai.

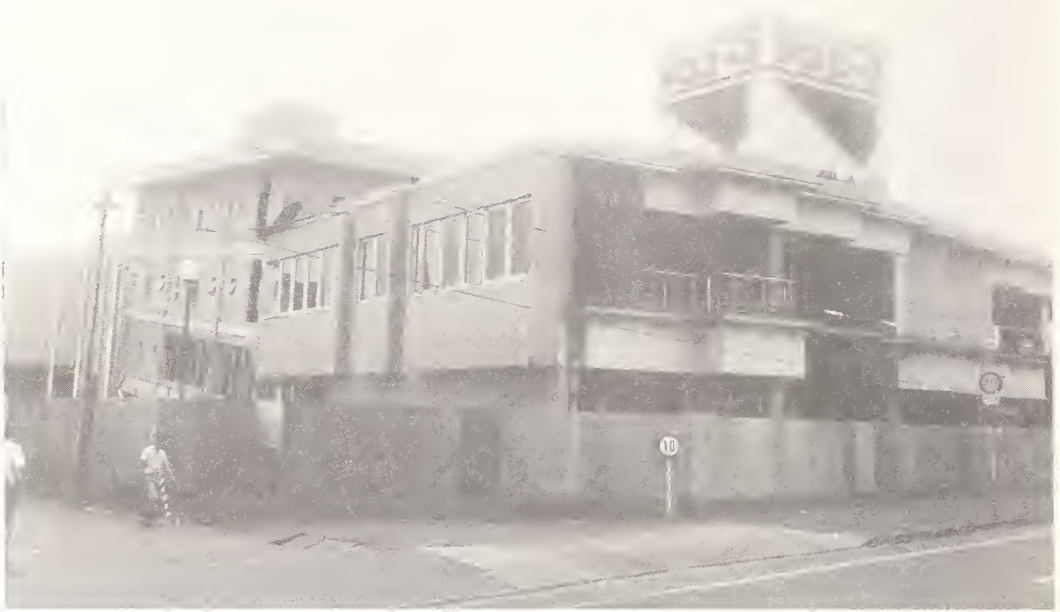
The strong N-S component of the earthquake caused shear failures in the first story concrete columns in the middle building and a collapse at the ground story, causing the entire building to tilt north. This racked the two-story steel frame building forward, causing extensive damage to the steel frame and popping glass panes from showroom windows. The area of impact between the two buildings is shown in Figures 5.39 and 5.40 and 5.41. Figure 5.42 shows a detail of the beam-column joint at the top of the first-story column on the east side of the middle building. The column shear failure extended up into the beam. A detail of the column on the northeast corner of the middle building in Figure 5.43 shows the gross vertical displacement and badly distorted bars in the columns. Unlike the other collapsed buildings in the Oroshicho area, deformed reinforcing bars were used in the Yazaki building. The building service systems between the two impacted buildings were damaged.

Figure 5.38 Yazaki Industries Buildings, viewed from the northeast, Oroshicho area. Portions of three Yazaki buildings are shown. Failure of the reinforced concrete middle building caused it to rack forward against the front steel structure.

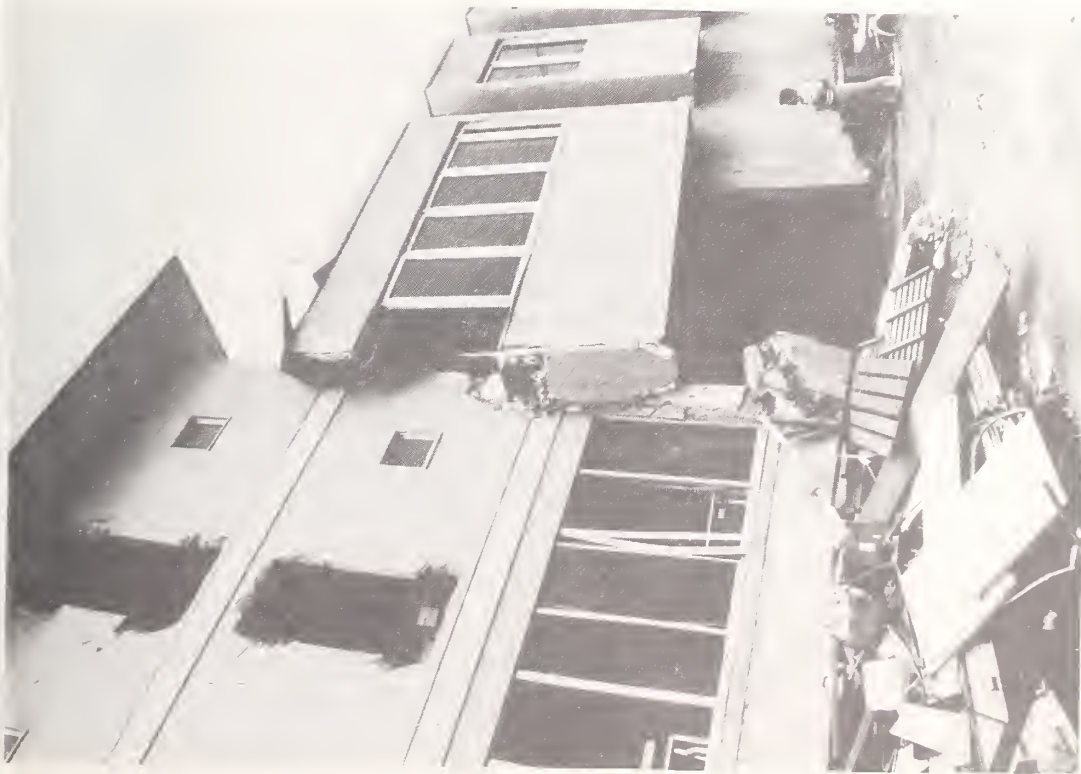
Figure 5.40 Yazaki Industries, showing area of impact between steel and reinforced concrete frames.

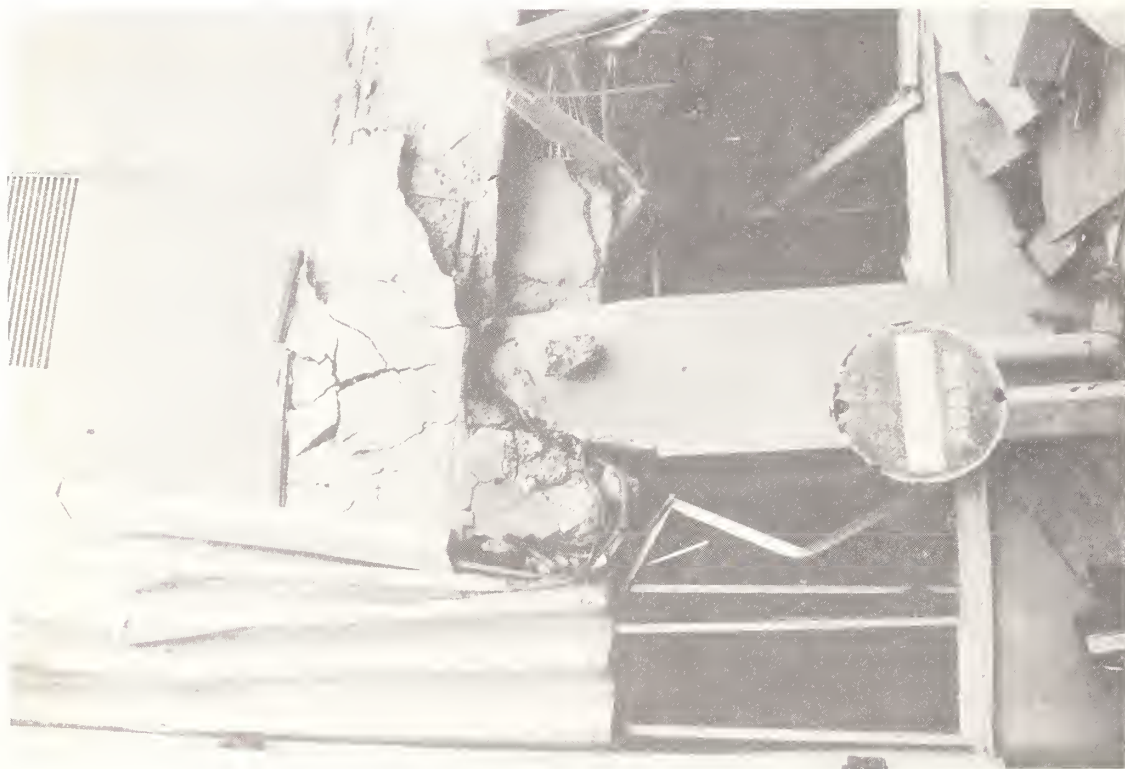
Figure 5.42 Yazaki Industries Building, showing beam-column joint at top of first

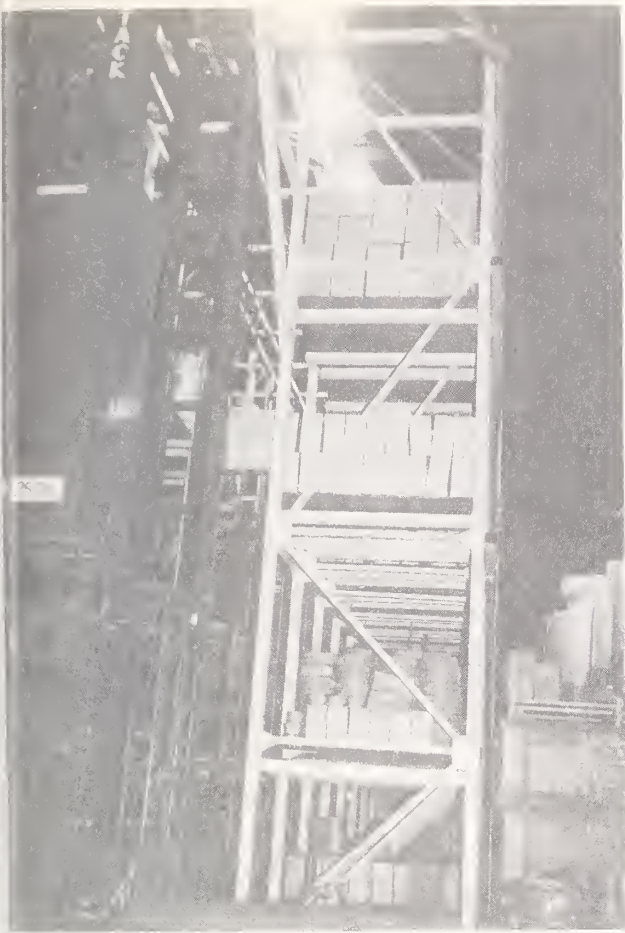
The steel frame warehouse behind the collapsed building (Figure 5.38) did not appear to be damaged. The warehouse contained numerous heavy tubular steel frame storage racks with diagonal braces, as shown in Figure 5.44. The storage racks stand approximately 7 m in height and are anchored to the concrete floor by being bolted or welded to steel plates in the floor. Although none of the racks had collapsed, the bottom diagonal braces appeared to have buckled on several racks, as shown in Figure 5.45.

Figure 5.44 Yazaki Industries warehouse building. A number of multi-level tubular steel storage racks had damaged transverse braces at ground level.

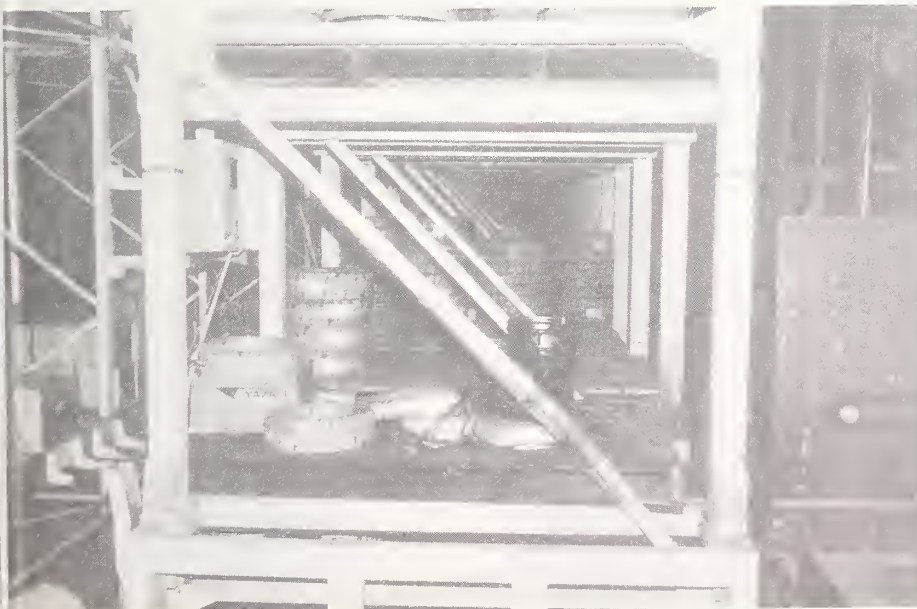
Figure 5.45 Yazaki Industries warehouse. Detail of diagonal brace at bottom of storage rack.

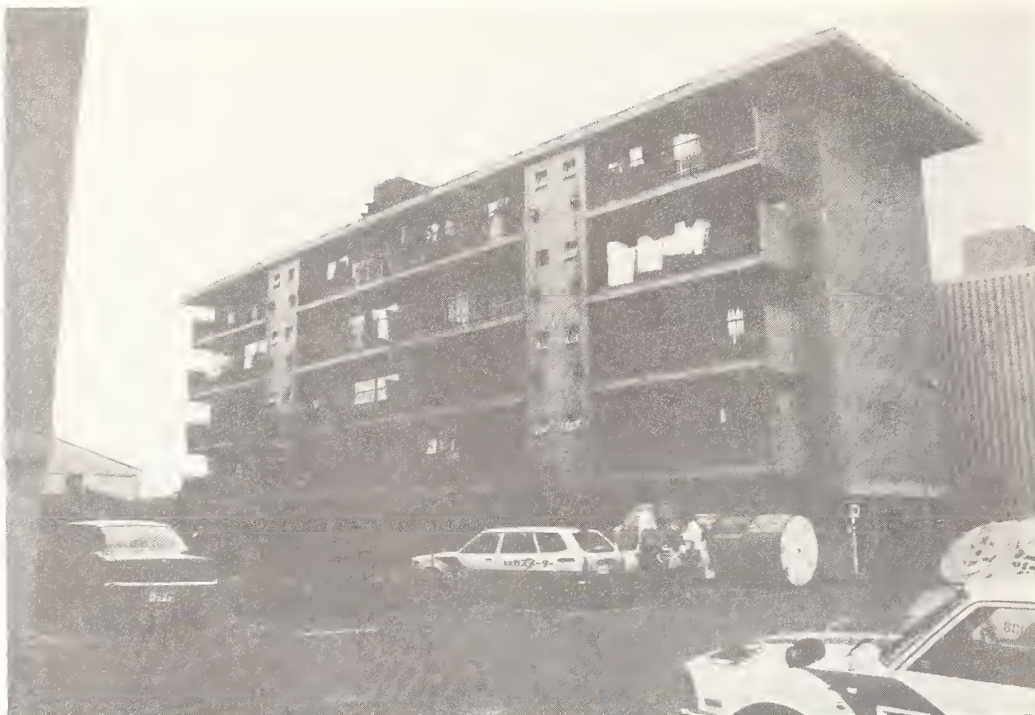
Figure 5.46 Apartment building adjacent to Yazaki Industries warehouse building to the south. The building was undamaged.

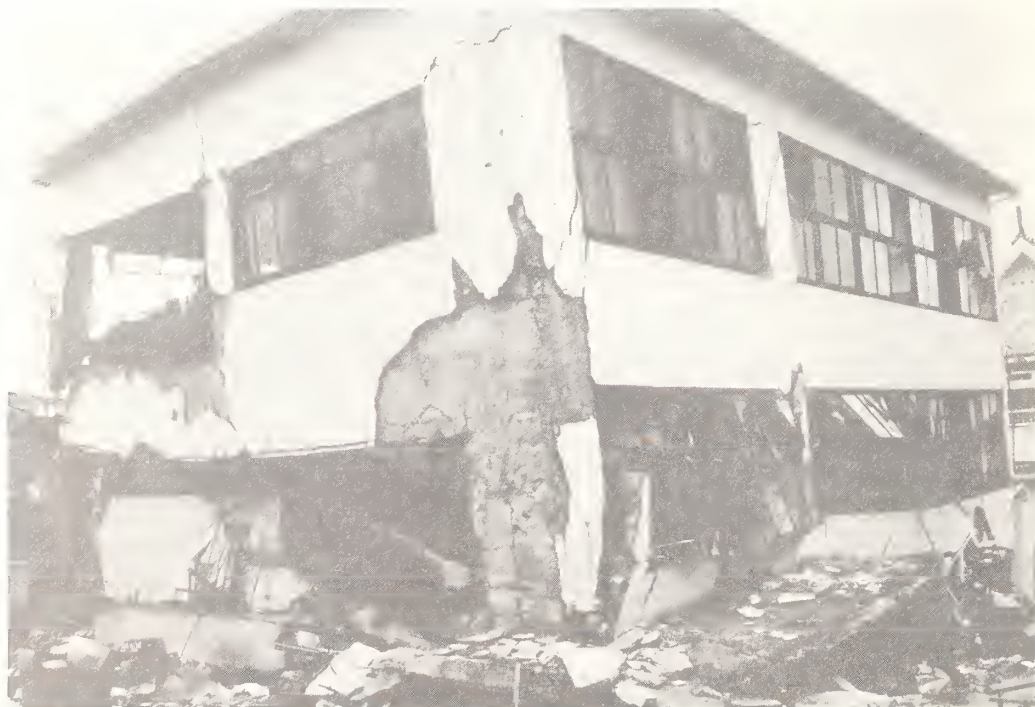
Paloma Building (No. 12, Figure 5.3). This reinforced concrete frame structure faced north and was located on Japan National Highway 45. It was a three-story rectangular building, two spans by three, with a shear wall on the west end of the building. The first floor was used for display, and had a large open area on the north and east side of the first floor. The main axis of the building ran in the E-W direction. Figures 5.4 and 5.48 show the Paloma Building viewed from the east following the earthquake. Failure occurred in the columns at this end of the building, causing the building to tilt toward the east. However, the shear wall at the west end of the building was also badly damaged (Figures 5.49 and 5.50). It is likely that the eccentricity caused by the presence of the shear wall on only one end of the building caused a torsional mode of failure for the structure.

Figure 5.47 Paloma Building - Viewed from the east. Collapse occurred at the east end of the building.

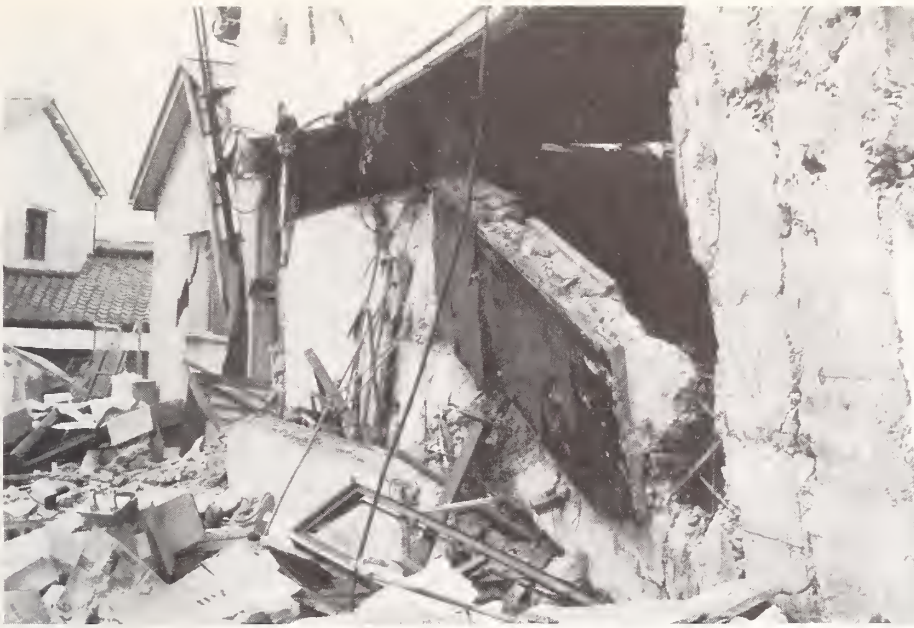
Figure 5.48 Paloma Building. Detail of first story, east end, showing inferior quality concrete.
